# Geology

Mountain Fire BAER  
(San Bernardino NF)

August 1, 2013

Jerome V. DeGraff, Sierra NF

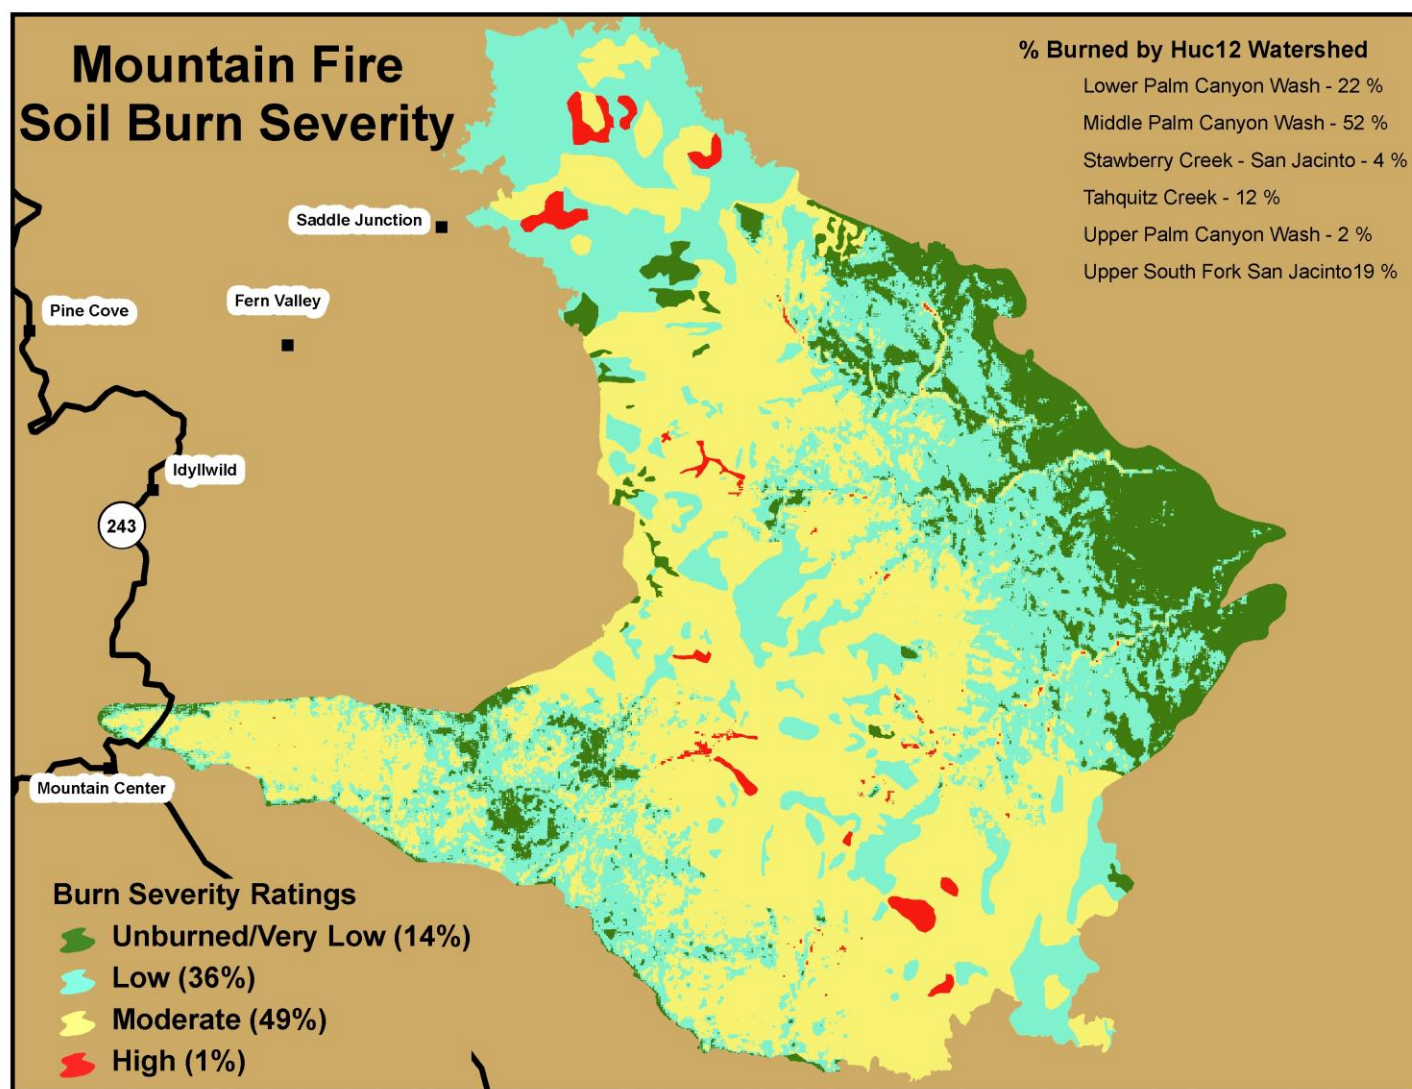
Figure 1. Map showing the soil burn severity map for the entire Mountain fire area. The location of some communities and State Highway 243 are shown for location context.

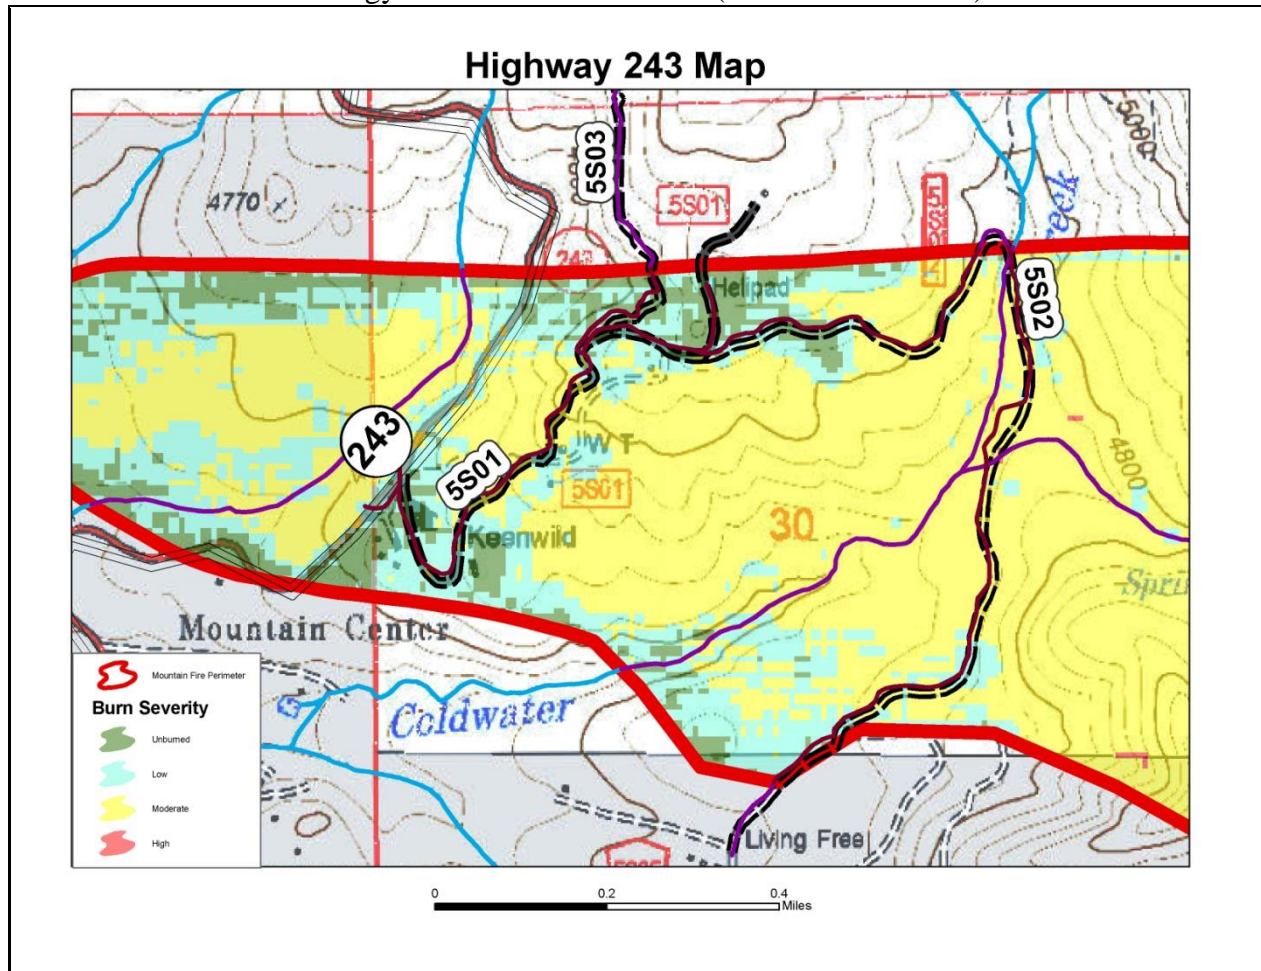
**Problem:** Near Keenwild Fire Station, State Highway 243 between Idyllwild and Mountain Center passes through a corner of the Mountain Fire perimeter. A burned area of concern is the slope above Highway 243 just north of Keenwild Fire Station (Fig. 1). The burned slope of concern is bounded on the west by Highway 243, north by the fire perimeter, on the south by a line extending east from the junction of State Highway 243 and Forest Road 5S01 (the road into Keenwild Fire Station), and on the east by Forest Road 5S01 where it passes along the top of the slope on the way to Keenwild Helibase.

Usually, rock movement and dry ravel occur as the fire passes over the area and shortly afterwards. The absence of this evidence of movement adjacent to Highway 243 suggests little rockfall has occurred. This may change during future storm events. The movement of individual rocks into the road bed is the most likely rockfall event in the future. While this seems a low likelihood event, given the evidence to date, it only takes a single rock being unexpectedly struck by a motorist or motorcyclist failing to see it in time.

Figure 1. Location of burned slope between Highway 243 and Forest road 5501 near Keenwild Fire Station and Helibase evaluated for rockfall hazard.
